SERVICE
TIPS & INFOS

Piston damage – recognising and rectifying!

3.4 Damage due to abnormal combustion

Piston Damage and causes

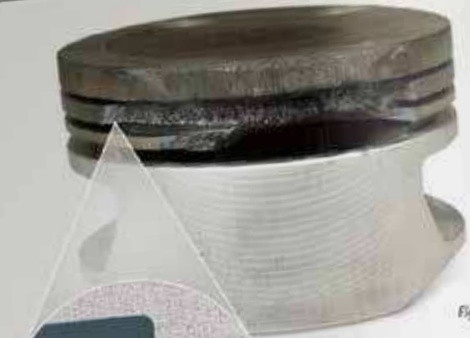
Fig. 1

- Description of the damage**
- Ring land fracture on one side of the piston between the first and second compression ring (Fig. 1).
 - Fracture, starting at the groove base at the top and running at a diagonal angle into the piston material, emerging at the groove base underneath (Fig. 2).
 - Fracture is extended downwards.
 - No piston seizure marks or signs of overheating.

Land fractures are not caused by material faults, but by material overload. A distinction can be made between 3 different causes:

1. Knocking combustion: The octane rating of the fuel was not capable of covering the engine's needs under all operating and load conditions (refer to the chapter entitled "General information about piston damage due to abnormal combustion in petrol engines").

Ring land fractures caused by knocking combustion usually occur on the pressure side. On a diesel engine, knocking combustion is caused by an ignition delay.

2. Hydraulic locks: Liquid (water, coolant, oil or fuel) accidentally enters the combustion chamber when the engine is stopped or running. As the liquid is incompressible, the piston and crankshaft drive are subjected to enormous stresses during the compression cycle. This results in ring land fractures, boss fractures or connecting rod/crankshaft damage.

3. Installation faults: If the piston rings are incorrectly compressed, more force is required when installing the piston. Forcibly pressing in or knocking in the piston causes pre-damage to the ring lands in the form of fine hair-line cracks.

- Knocking combustion on petrol engines:**
- Fuel without suitable anti-knock properties. The fuel quality must correspond to the compression ratio of the engine, i.e. the octane rating of the fuel must cover the octane requirements of the engine under all operating conditions.
 - Petrol contaminated by diesel, which lowers the octane rating of the fuel.
 - Excessively high compression ratio caused by excessive machining of the engine block surface and cylinder head mating surface, e.g. for engine reconditioning or tuning purposes.
 - Ignition timing too advanced.
 - Mixture too lean, resulting in higher combustion temperatures.
 - Intake air temperatures too high, caused for example by inadequate ventilation of the engine compartment or incorrect switching of the intake air flap to summer operation (particularly on older carburetor engines).

- Knocking combustion on diesel engines:**
- Injection nozzles worn or leaks.
 - Injection pressure too low.
 - Compression pressure too low.
 - Defective cylinder piston protrusion or damaged/worn piston rings.
 - Defective cylinder head gasket.
 - Damage to the cylinder head.
 - Improper or excessive starting (e.g. starting stop).
 - Defective turbocharger.

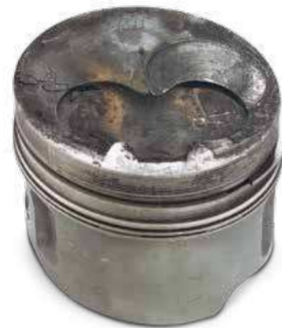
Fused / melted off material

- Faulty injectors
- Incorrect quantity of injected fuel
- Incorrect injection timing
- Insufficient compression
- Ignition delay
- Oscillations in the fuel-injection lines
