Engine bearing failures and how to avoid them

Dr. Dmitri Kopeliovich (Research & Development Manager, King Engine Bearings)

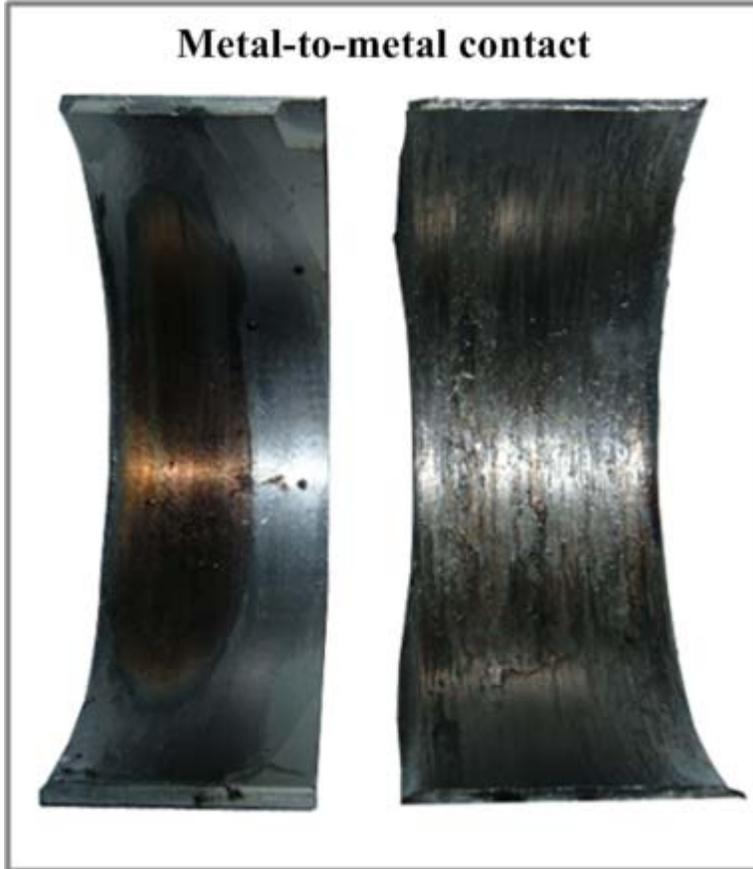
- **Accelerated wear:** is when the bearing is not overheated and only a shiny appearance of the bearing surface is observed.
- **Wiping or heavy wear:** this appears in the form of overheating and partial melting of the overlay (the left part of the Fig.1).
- **Severe wear or Hot Short:** it results in torn surfaces, severe overheating, melted overlay and lining material (right part of the Fig.1).

Fig.1 Metal-to-metal contact

Bearing failures due to metal-to-metal contact	
Cause	Solution
Insufficient oil supply (oil starvation)	Check oil supply system (e.g. clean clogged oil passages ,insufficient clearance, etc)
Breaking the oil film (due to oil contamination or bearing material fatigue)	Change bearing material (tri-metal instead of bi-metal) or solve overloading problem
Misalignment (e.g. out-of-shape grinding, distorted connecting rod)	Correct deficient machining, fix/replace distorted parts
Poor journal surface finish	Verify proper grinding/polishing procedures
Foreign particles embedded in the bearing surface	Determine origin of particles, improve cleaning procedures prior to assembly. Clean parts with hot soapy water. Do not clean with solvents
Low viscosity oil (diluted with fuel or coolant)	Identify/address source of oil dilution, use higher viscosity oil
Grinding chatter marks (waviness) and lobing	Check crank grinder table + wheel bearings for excessive play, replace/re-grind crankshaft

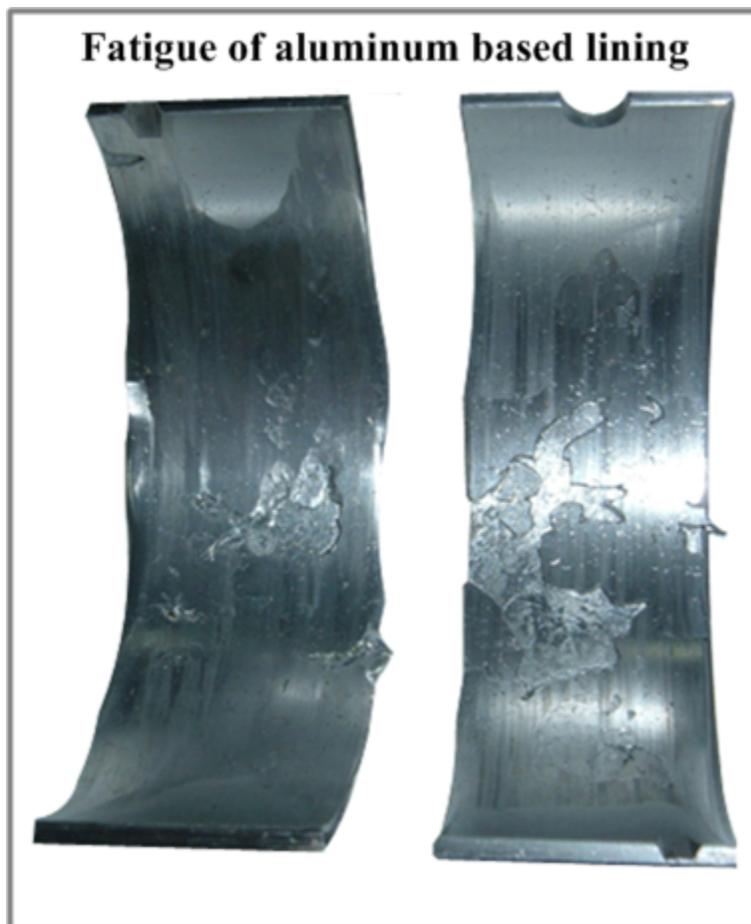
Fatigue of an aluminum lining. The fatigue cracks form on the surface and propagate inside the lining reaching the steel back.

The cracks then progress along the bond line between the lining and the steel.

Pieces of the lining flake out from the steel back resulting in oil contamination and eventual bearing failure.

Fatigue of aluminum alloys may also cause extrusion of the lining material past the length of the bearing edges.

Fig.2 Fatigue of aluminum lining of bi-metal bearings

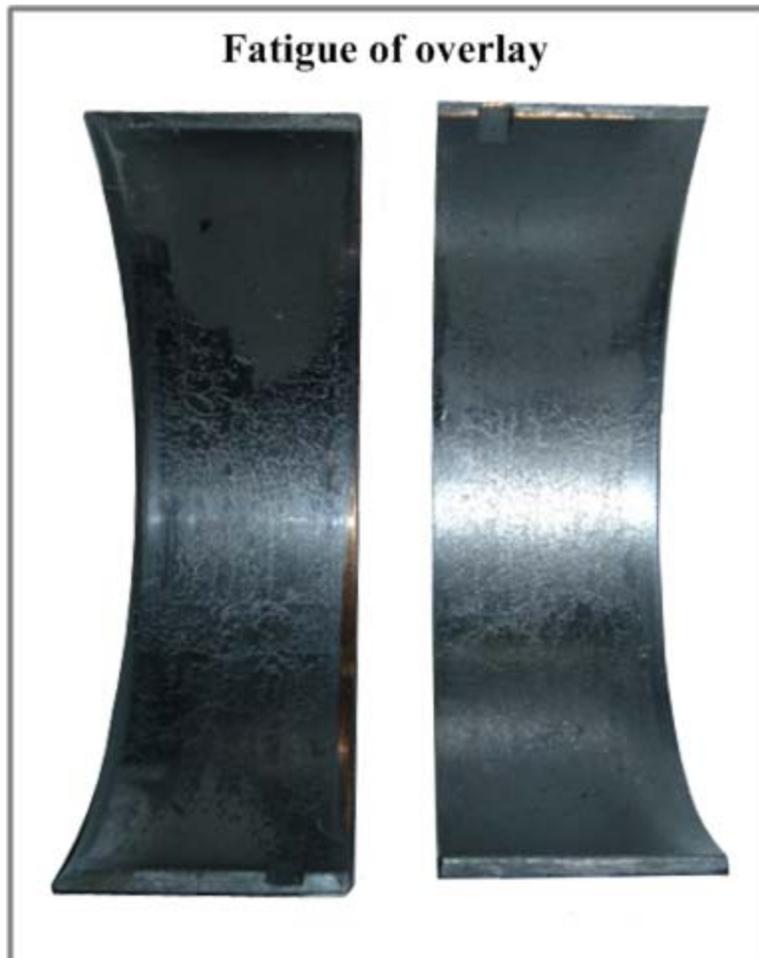
- **Fatigue of a tri-metal overlay.** Spider web-like cracks are seen on the surface (Fig.4). Fatigue limit of an overlay is determined by the strength of the material and the thickness of the overlay. The thinner the overlay, the higher its fatigue strength.

Overlay fatigue itself does not cause the bearing to fail.

However, running the bearing with fatigued overlay may cause partial flaking of the overlay, lowering the oil film thickness and eventual seizure of the exposed intermediate layer.

Fig.3 Fatigue of the overlay of tri-metal bearings

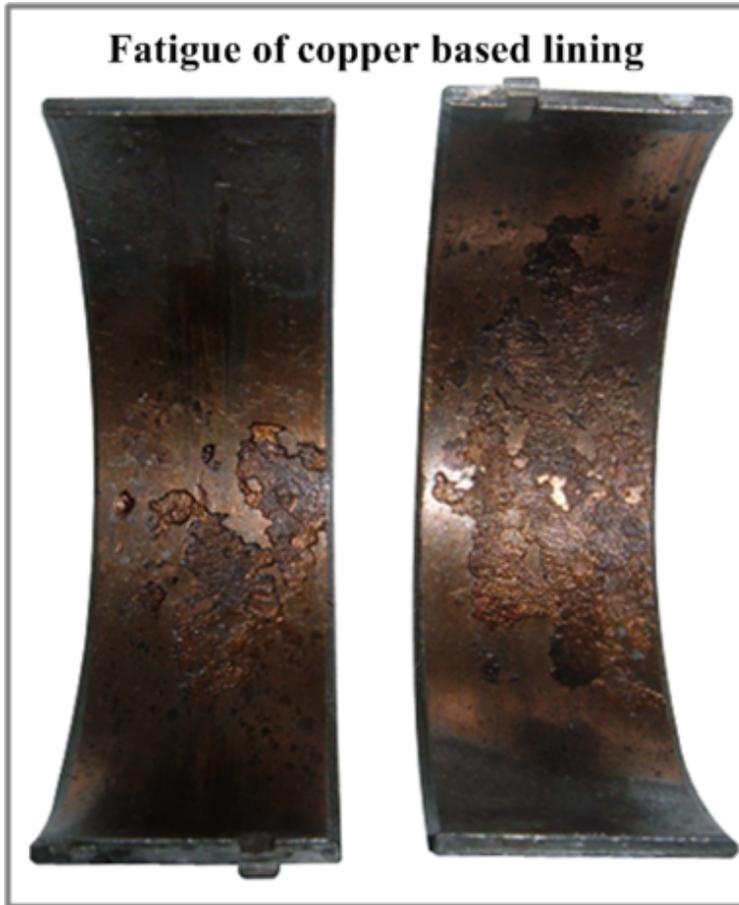
- **Fatigue of a copper based intermediate layer.** Fatigue of a copper based lining (Fig.4) starts from a fatigue of the overlay. The overlay flakes out from the copper lining resulting in an interruption of the oil film, breaking the hydrodynamic lubrication regime. The load localizes at the contact area causing formation of small cracks on the lining surface. The cracks then propagate throughout the lining thickness, meeting the steel back surface and continuing to advance along the steel-copper boundary. As a result, parts of the intermediate layer detach from the steel surface.

Fig.4 Fatigue of the copper based intermediate layer of tri-metal bearings

Engine bearing failures due to fatigue	
Cause	Solution
Wrong selection of engine bearing material	Change to a bearing material with higher load capacity (e.g. tri-metal instead of bi-metal)
Fuel detonation / advanced ignition	Retard ignition or use a fuel with higher octane number
Running engine at high torque and low RPM for a long time (climbing)	Change to bearing material with higher load capacity (e.g. tri-metal instead of bi-metal)
Poor conforming of the bearing back with the housing surface	<ol style="list-style-type: none"> 1. Check the bearing crush height 2. Properly re-size the housing
Oil starvation causing localization of load at particular bearing areas	Check oil supply system for clogged oil passages, check clearances, component geometry, oil pressure + volume
Geometry misalignments causing localization of bearing loading	Fix/replace distorted parts or use more conformable material (bi-metal instead of tri-metal)

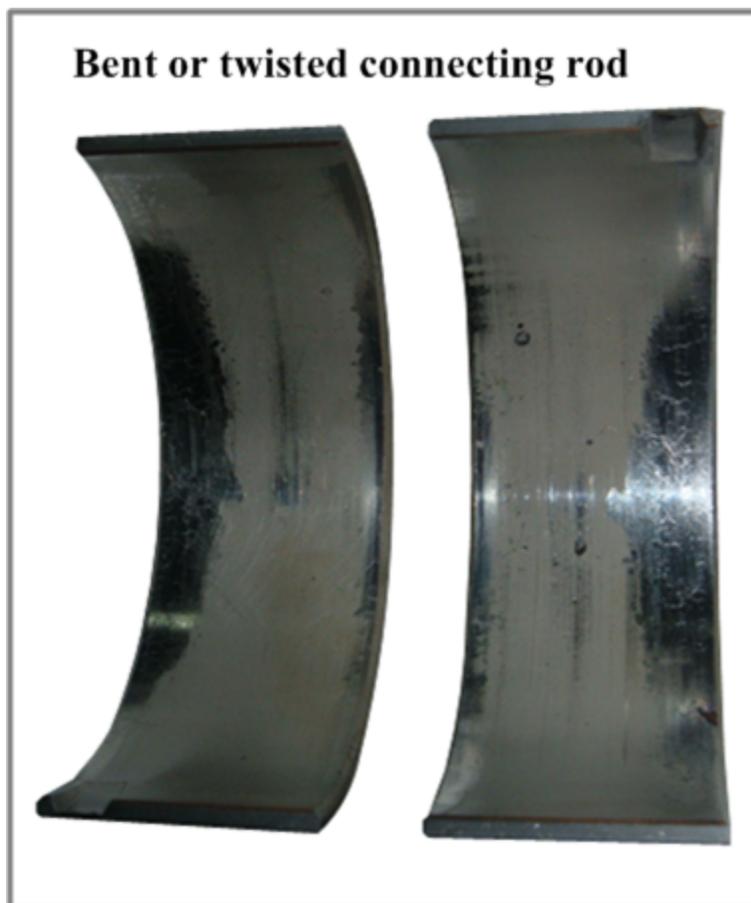
Both problems are seen in the picture: local wear with shiny appearance and the overlay fatigue in form of spider web like cracks on the areas of metal-to-metal contact.

- **Distorted (bent or twisted connecting rod)** is one of the causes of localized loading of engine bearings (Fig.5).
Overloading of an internal combustion engine due to detonation or running under high torque at low rotation speed may cause distortion of the connecting rods. The distortion results in non-parallel orientation of the bearing and journal surfaces.
The non-parallelism causes localized excessive wear of the bearing surface due to metal-to-metal contact (boundary or mixed lubrication) occurring near the bearing edge.
Localized metal-to-metal contact may also cause fatigue cracking of the bearing material in the locations of the contact.

Fig. 5 Bent or twisted connecting rod

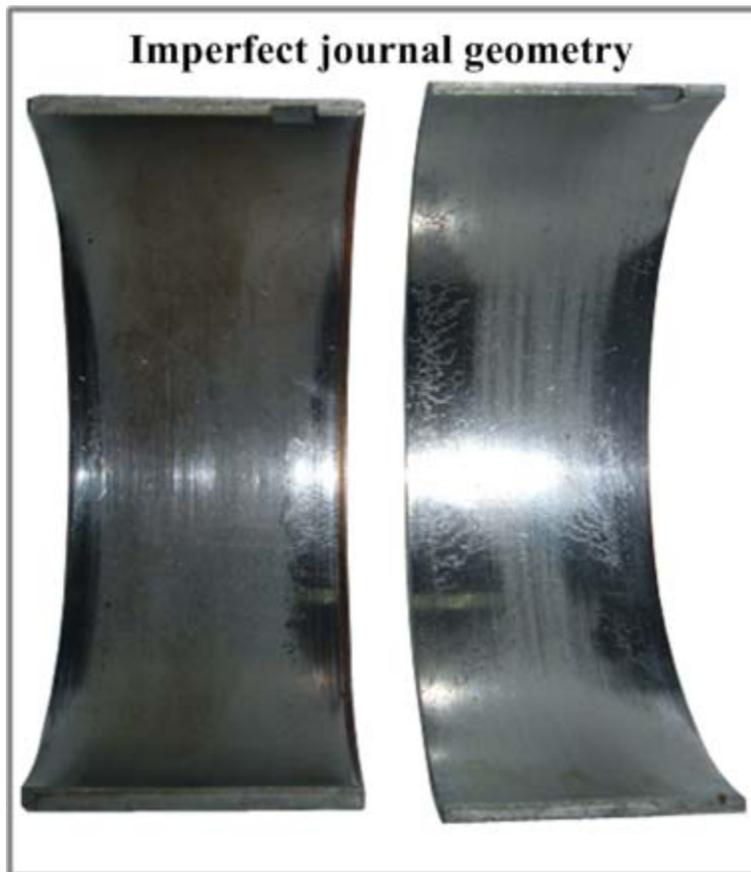
- **Imperfect journal geometry** is another cause of localized loading of engine bearings (Fig. 6).
Use of a worn stone in grinding a crankshaft results in obtaining an imperfect (out-of-shape) journal surface: taper shape, hour glass shape or barrel shape. The parts of the journal surface having higher diameter (central part of the barrel shape journal, edge parts of hour glass shape journal) come to metal-to-metal contact (boundary lubrication) with the bearing surface. The metal-to-metal contact causes excessive wear. Fatigue cracking of the bearing materials may occur in the contact areas.

Fig. 6 Imperfect journal geometry

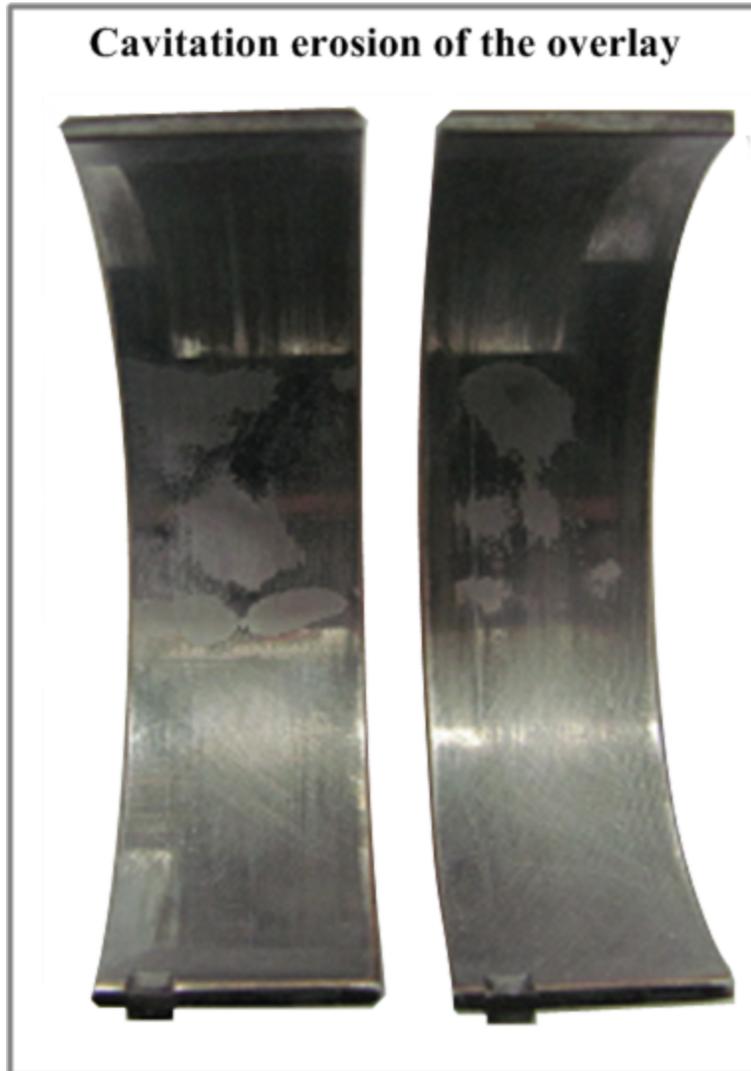
Cavitation occurs when the load applied to the bearing fluctuates at high frequency (high RPM). The oil pressure instantly falls causing formation of bubbles (cavities) due to fast evaporation. When the pressure rises the cavitation bubbles collapse at high velocity. Such collapse results in impact pressure, which can erode the bearing material (Fig.7).

Fig.7 Cavitation erosion of soft lead based overlay

Soft lead based overlays of tri-metal bearings are prone to the cavitation erosion. Therefore replacement of tri-metal bearings with babbitt overlay with bi-metal material or with high strength tri-metal bearings (e.g. GP) will prevent the failures due to cavitation.
